URGENT FIELD SAFETY NOTICE / PRODUCT NOTIFICATION

Subject: ExacTrac Dynamic - Patient Positioning System:
For CBCT positioning workflows using setup beams with Varian LINACS, yaw angle may be incorrect

Product Reference: ExacTrac Dynamic 1.0.0, 1.0.1, 1.0.2, 1.0.3

Brainlab Identifier: CAPA-20220204-002455

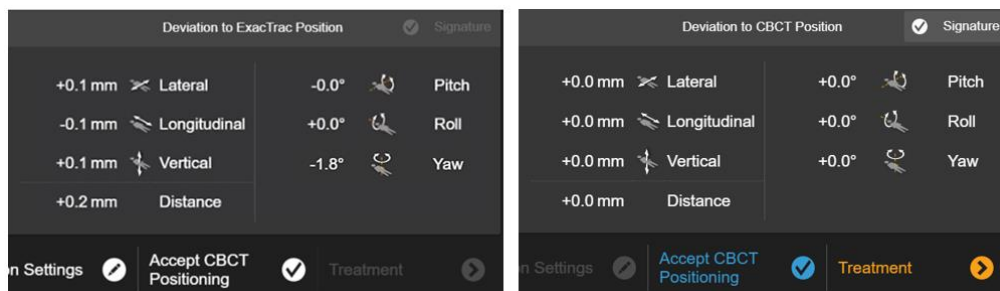
More specifically, it is calculated from the values displayed in the ETD software as shown in Figure 2a “Deviation to ExacTrac Position”, by inverting the signs. After the user selects “Accept CBCT Positioning”, the CBCT offset is added, such that the final ETD position results in 0mm/0° in all dimensions, indicating that from now on the CBCT position is accepted as the reference position (shown in Figure 2b).

Figure 2a (left): The deviation between the current patient position and the planned ExacTrac internal position. **Figure 2b (right):** The CBCT offset has been added to the ExacTrac internal position, resulting in 0mm/0° in all dimensions.

Once the user selects “Accept CBCT Positioning”, the displayed yaw value changes to 0 as displayed in Figure 2b. Thus the wrong ETD internal position and wrong CBCT offset initially compensate each other and lead to expected 0 result in all directions.

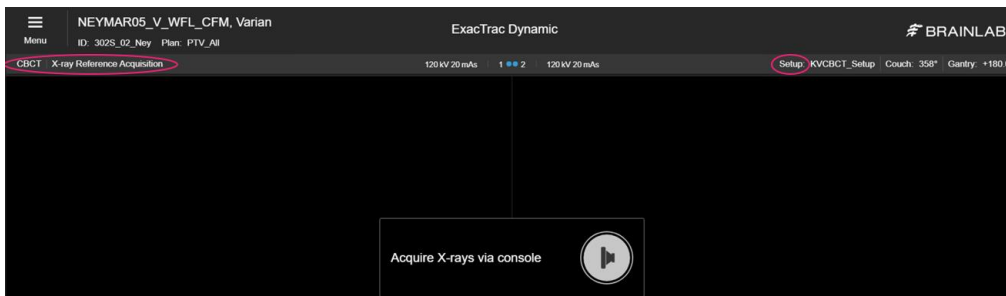
- The use of the CBCT module of ETD 1.0.x with an ETD system installed on a Varian LINAC
- The user starts the CBCT offset detection by acquiring X-ray images on the CBCT X-ray Reference Acquisition page while a setup beam is active on the LINAC, as shown in Figure 3
- The values for *original planned PSAs* and *updated planned PSAs* are different, when the CBCT offset detection is started
- After determining the CBCT offset, at least one additional X-ray pair is successfully acquired and evaluated while a treatment beam is selected at the LINAC.

Figure 3: The display of the CBCT X-ray Reference Acquisition page with a setup beam selected.

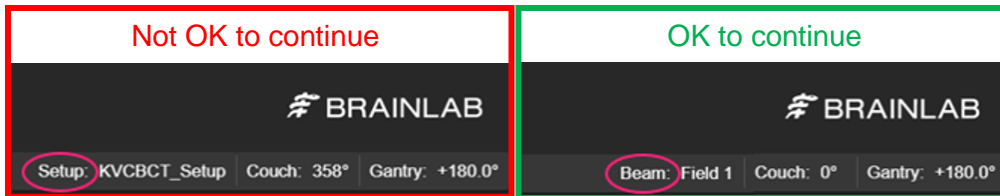
Figure 5: (left) A setup beam is active and it is not safe to continue; (right) A treatment beam is active and it is safe to continue.

When using the ETD CBCT module, always ensure that during the “CBCT X-ray Reference Acquisition” step (CBCT offset detection), a treatment beam and not a setup beam is loaded on the Varian treatment console. If a setup beam is loaded, the word “Setup” will display in the ETD software, and it is **not** safe to continue; see Figure 5. In this case make sure you first switch to a treatment beam on the Varian treatment console and confirm the change in the Brainlab ETD software before continuing.
