Pilne zawiadomienie dotyczące bezpieczeństwa

**Błąd systemowy walidacji danych aplikacji Intellis™
Model A710 Aktualizacja oprogramowania do wersji 1.3.130**
Aktualizacja oprogramowania

Grudzień 2020 r.

Nr ref. Medtronic: FA949

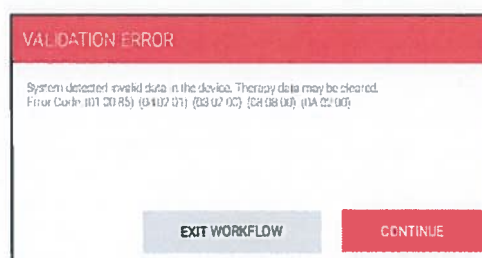
Rysunek 1: Komunikat błędu walidacji

Firma Medtronic otrzymała czternaście (14) raportów w okresie od stycznia 2020 r. do 24 listopada 2020 r., w których użytkownicy napotkali na błąd walidacji (Rysunek 1), a następnie błąd systemowy (Rysunek 2) oprogramowania aplikacji programatora klinicznego CT900 A710 Intellis w wersji 1.3.80 wskazujący, że aktualizacja programowania stymulatora nie mogła zostać ukończona. Po zbadaniu przyczyn problemu stwierdzono, iż została uszkodzona określona lokalizacja pamięci stymulatora, a aplikacja oprogramowania Intellis A710 w wersji 1.3.80 nie usunęła uszkodzenia, pomimo odpowiedniego zaprogramowania, co spowodowało błąd systemowy. Niniejszy błąd systemowy nie jest częstym zdarzeniem, a wskaźnik jego występowania został zgłoszony jako niższy niż 1 na 10 000.

Problem ten pojawia się i jest rozpoznawany w warunkach klinicznych, kiedy pacjent znajduje się pod opieką pracownika służby zdrowia. Jeśli **przed** instalacją najnowszej wersji oprogramowania aplikacji A710 Intellis v1.3.130 pojawi się VALIDATION ERROR (Błąd walidacji) (jak pokazano na rysunku) z kodem błędu (01 00 85) (04 02 01) (03 02 00) (08 08 00) (0A 02 00) należy wybrać opcję "**CONTINUE**" (Kontynuuj). W przypadku wybrania opcji "**EXIT WORKFLOW**" (Zakończ proces) należy ponownie nawiązać komunikację i wybrać opcję "**CONTINUE**" (Kontynuuj), gdy wyświetli się VALIDATION ERROR (BŁĄD WALIDACJI) (rys. 1).

Prosimy o pobranie najnowszej aktualizacji oprogramowania aplikacji Intellis A710 w wersji 1.3.130 programatora klinicznego CT900, zgodnie z załączoną instrukcją.

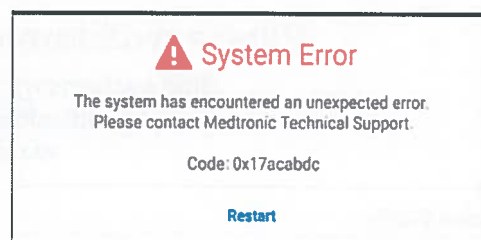
Rysunek 2: Komunikat błędu systemowego

Po wybraniu opcji "**CONTINUE**" (Kontynuuj), jeśli wyświetli się komunikat "**System Error**" (Błąd systemowy) (Rysunek 2) należy skontaktować się z przedstawicielem firmy Medtronic w celu uzyskania pomocy przy pobieraniu najnowszej wersji v1.3.130 oprogramowania aplikacji A710 Intellis. Po pobraniu najnowszej wersji v1.3.130 oprogramowania aplikacji Intellis należy ponownie nawiązać komunikację i wybrać opcję "**CONTINUE**" (Kontynuuj), aby usunąć ten problem.
